April 14, 2016

# ABOSN Test Finding for 4' x 8' Mat

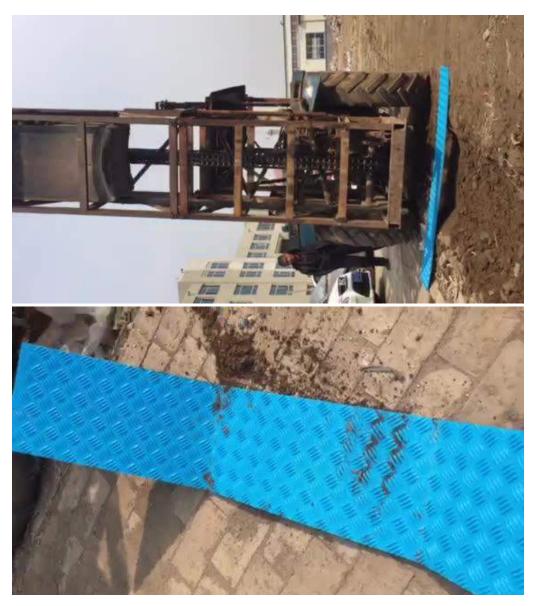
#### Test 2

A weight of 385 pounds was used to conduct a puncture test to measure the strength of material. It was raised and dropped from 3m height onto the surface of the mat. The mat was safe and sound. ( see picture)

ABOSN 4' x 8' Mat		
Drop Height	Result	
3 meters	Safe and sound

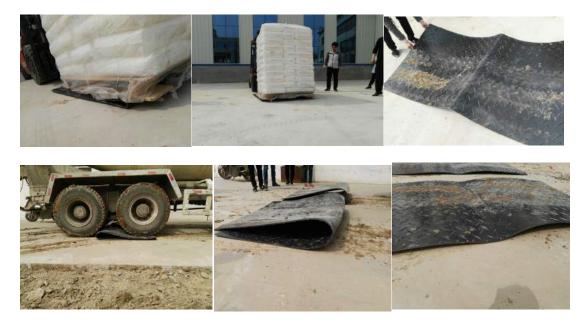
Test 3

A fold test was conducted to evaluate the flexibility, stiffness and strength of the material. The mat was folded over and a load ( 3300 pounds ) applied to the mat and folded access by the truck with 40 tonnes. Rolling 6 times continuously for front and back. ( see pictures) Video : <u>https://www.youtube.com/watch?v=9RCkJoEgrgs</u>

ABOSN 4' x 8' Mat	
Weight	Result
3300 pounds for load	No breakage, returned to shape
40 tonnes for truck	No breakage, returned to shape

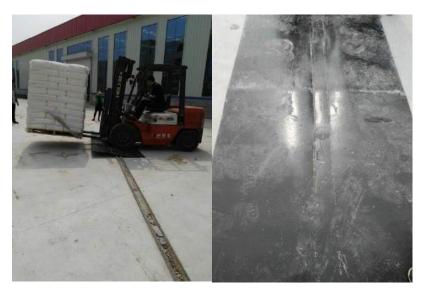
## Test 4

The mat put on the barrier, 2 tonnes forklift access it 10 times back and forth. No

break of the mat. (see pictures) Video:

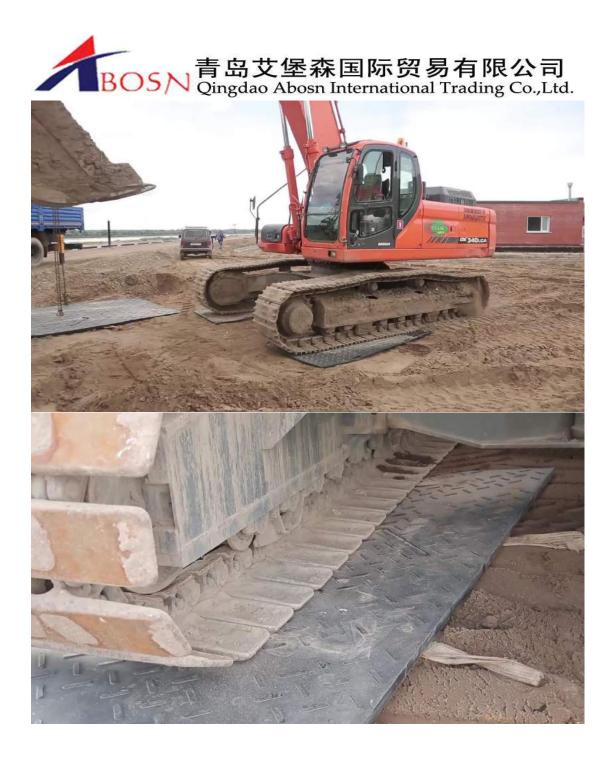
## Test 5

## Application Test (see pictures)

ABOSN 4' x 8' Mat		
Details	Result	
4' x 8' x $1/2$ '' HDPE Mat 40 tonnes truck,	No problem, normal use	
muddy ground		
15' x 7' x 3/2" UHMWPE Mat 100 tonnes	No problem, normal use	
crawler construction ground
